BOATING ACCIDENT INVESTIGATIONS 1974, FIRE AND  
EXPLOSION

Underwriters' Laboratories,  
Incorporated

Report No. CG-D-119-75

**DEPARTMENT OF TRANSPORTATION  
UNITED STATES COAST GUARD**

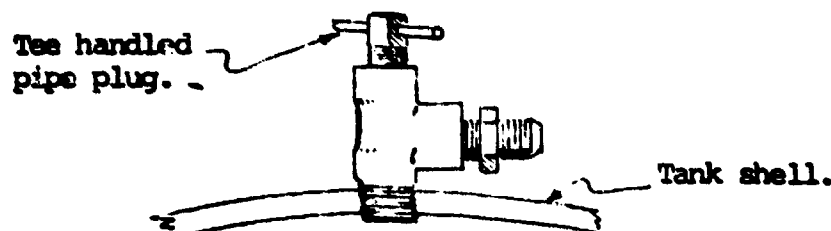
#### Case 1 1974

A pipe tee fitting was installed in the vent connection of each fuel tank with a 1/8 inch tee-handle pipe plug installed, apparently for the purpose of checking fuel level in the tank. The 3/8 inch diameter opening was too small for a normal dip-stick. The accident was caused by the tee plug falling out.

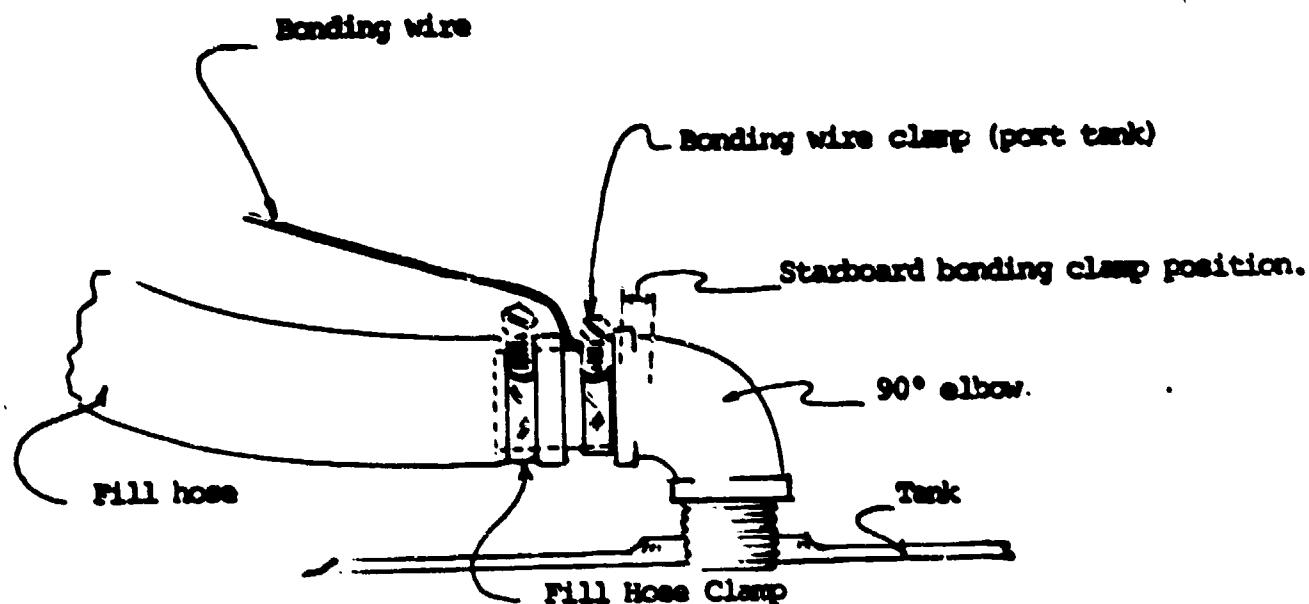
Case 3 1974

In this case, a bonding wire was clamped to the short pipe provided for attachment of the fill hose. Because of the very limited length of pipe left for clamping, the hose slipped off and when the tank was filled, the fuel was pumped onto the tank top instead of into the tank.

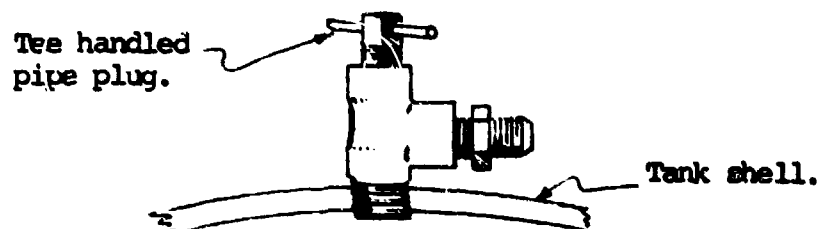
Figure No. 2

- a. Fuel Fill - The port fuel fill pipe was badly burned but was apparently still liquid tight after the fire. Only part of the fill system could be pressure checked. The multilayer fabric reinforced hose was double clamped and was provided with a bonding strap to the deck plate. The system could hold a maximum of 2/10 gallons, based on the location of the vent discharge.
- b. Vent System - Both fuel tanks were vented with 1/2 inch OD copper tubing through the hull side just below the sheer line. The vent discharge was about 18 inches above the tank top. The vent line was connected with a flare fitting to a tee fitting at the tank. See Figure No. 2.

When inspected, the tee handle plug was missing from the port fuel tank and is considered to be the source of fuel for the fire. The missing plug could not be located.

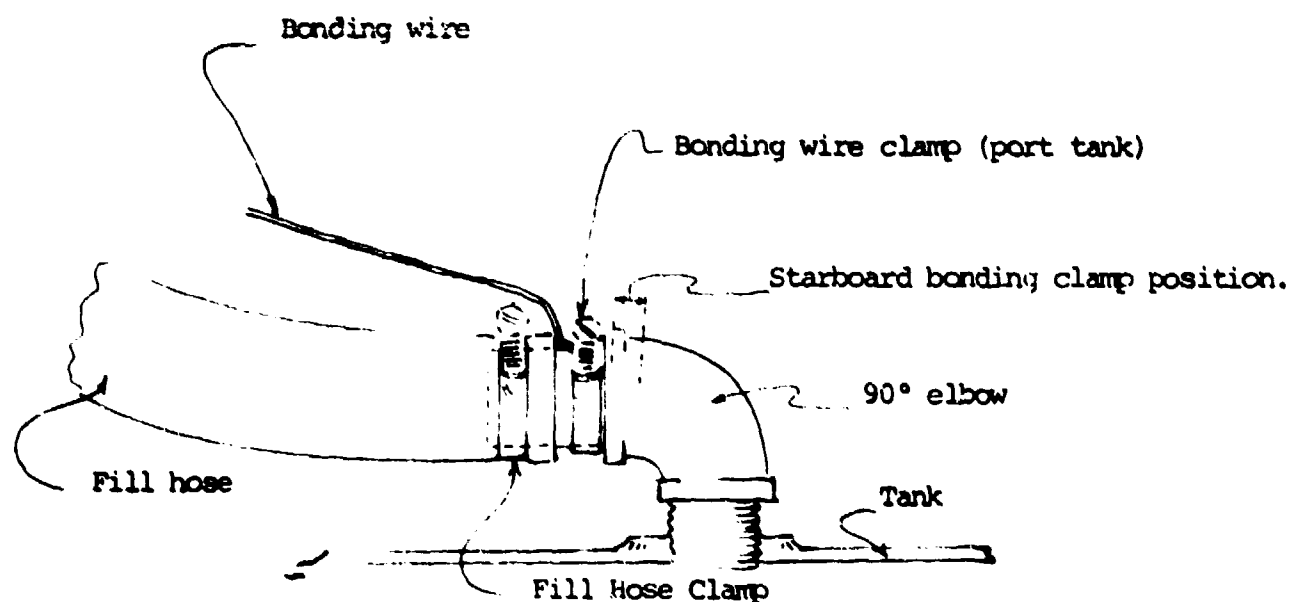
Figure 2

The actual probable cause was most likely the very short (2-5/8 inch) connection for the port fuel fill hose at the port tank. Since approximately 3/4 inch was used for the ground connection, only 1-7/8 of pipe remained for the fill hose connection.

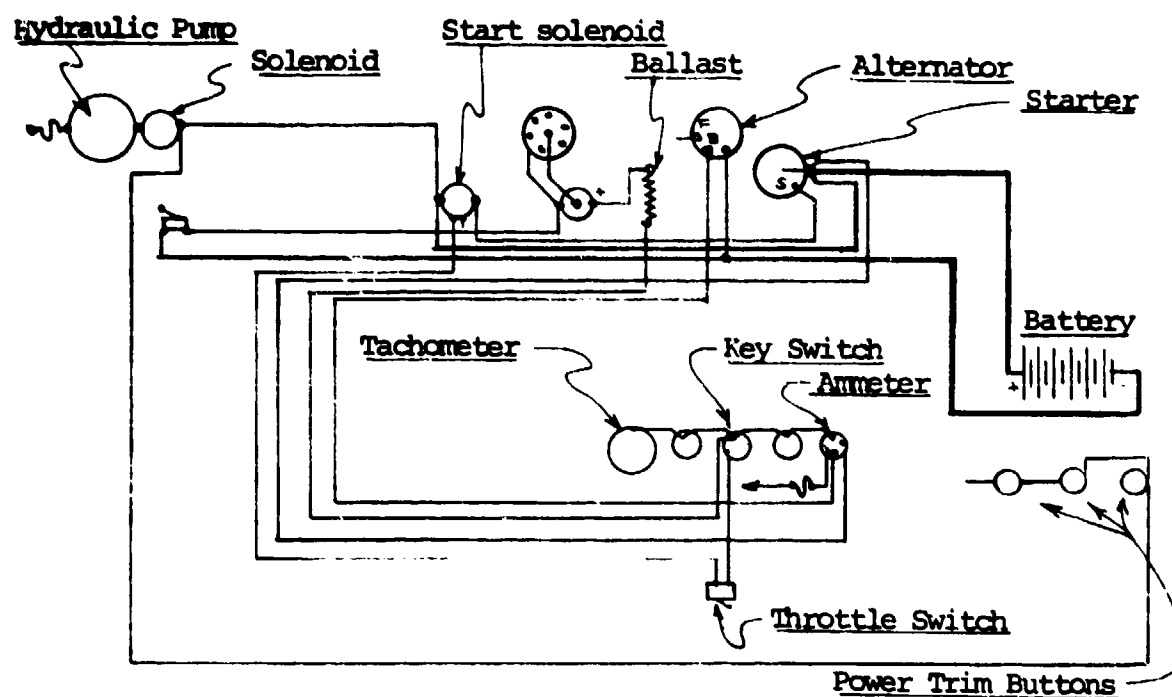
Figure 2

In this particular boat if the lead between the alternator battery terminal and the ammeter shorts to ground, the red and white wire from the engine space all the way to the instrument panel would probably ignite and burn since it is not protected. The resulting fire would then cause a second short in the unprotected lead from the ammeter to the starter, in the hot leads to all instruments and in the unprotected conductors to the power trim control. See Figure No. 2.

Approximate Diagram of Wiring Without Overcurrent Protection

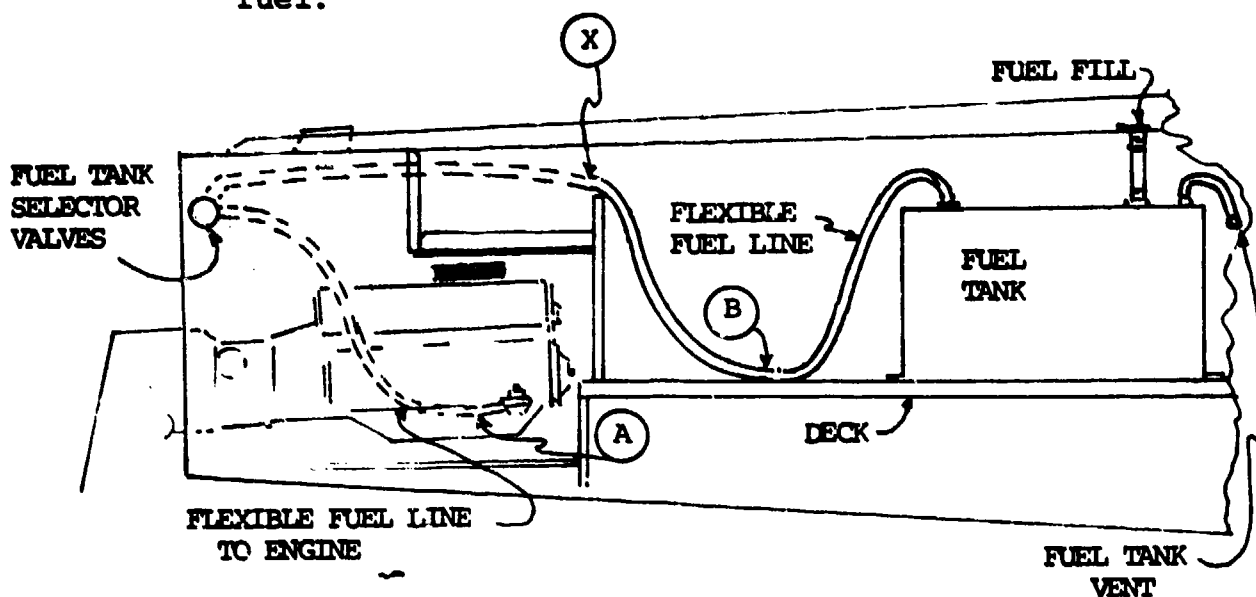
- (a) Fuel Feed Line - The fuel feed line was a full length section of SAEJ30 type hose from the tank to a selector valve assembly, aft of the engine. The unsupported flexible fuel line was installed as shown in Figure 1 and would siphon the tank if a break or leak occurred at point A or B. In this instance, it is believed that a leak occurred in Section A and that the initial small fire caused a total failure of the line permitting a continuous siphon feed of fuel.

over the bulkhead and burn the fuel feed line at point X  
(Figure 1).
